**SHENIPSIT LAKE DAM
CT. 00209**

**PHASE I INSPECTION REPORT
NATIONAL DAM INSPECTION PROGRAM**

SEPTEMBER 1978

Identification Number:	CT 00209
Name:	Shenipsit Lake Dam
Town:	Vernon
County and State:	Tolland County, Connecticut
Stream:	Hockanum River
Date of Inspection:	June 13, 1978

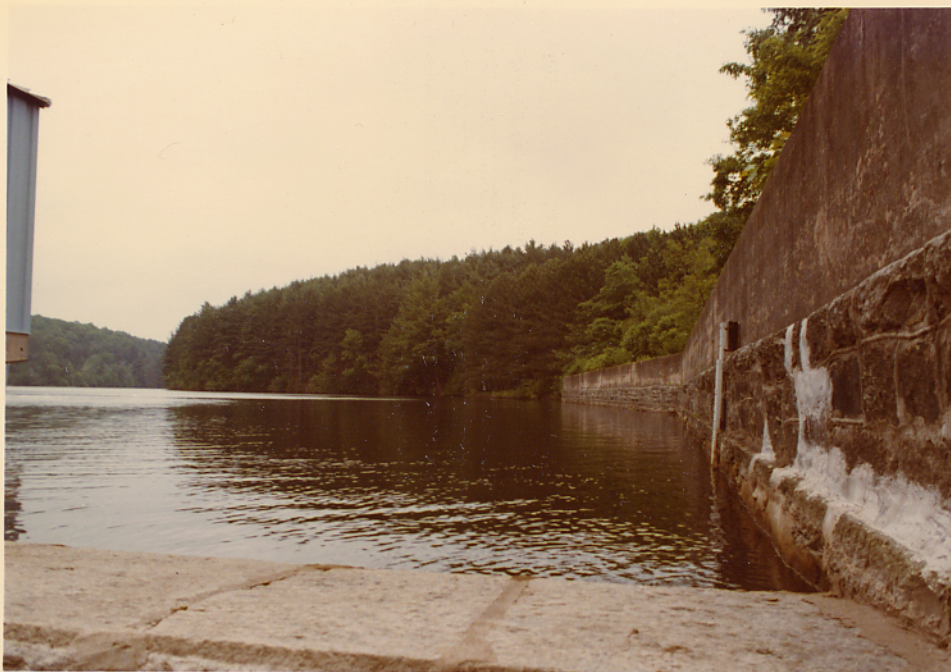
PHOTO 1
UPSTREAM EMBANKMENT RETAINING WALL

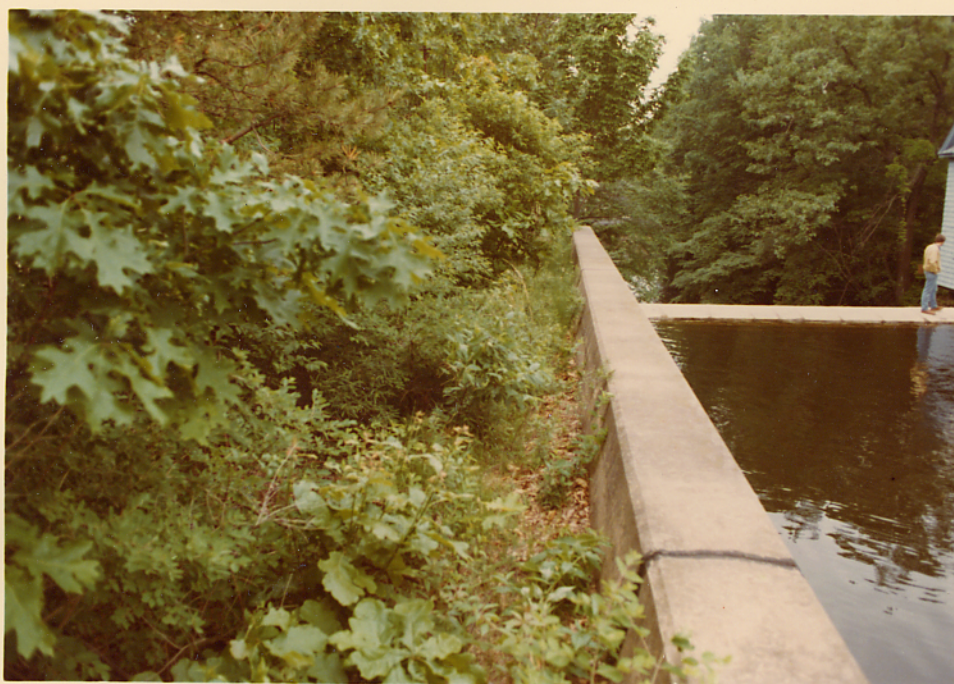
PHOTO 2
UPSTREAM FACE OF DAM AND ADJACENT EARTH EMBANKMENT
WITH RETAINING WALL

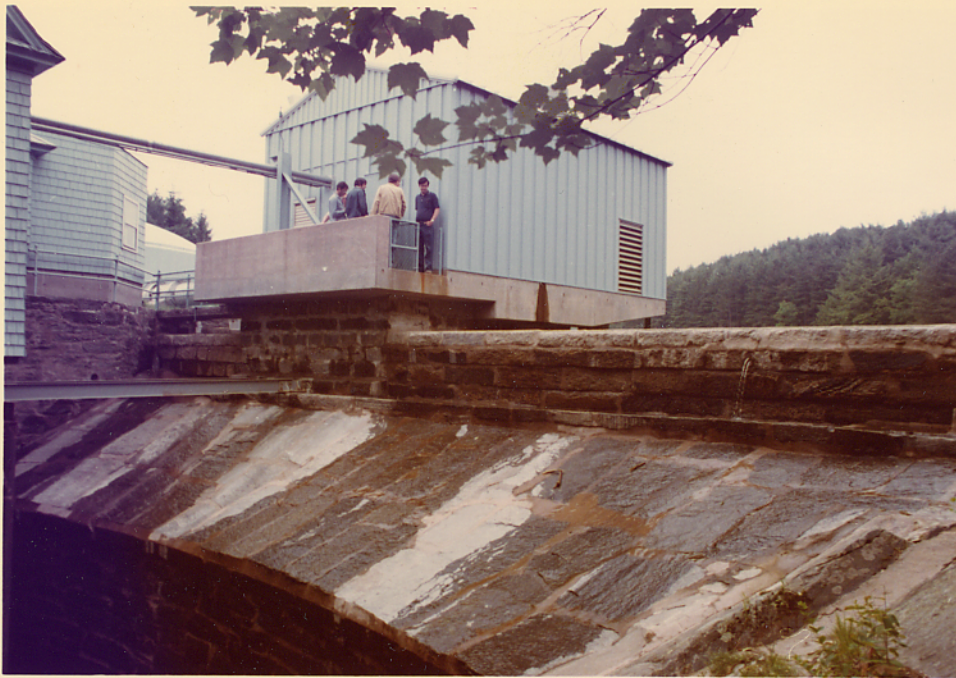
PHOTO 3
SPILLWAY - UPPER GATE HOUSE

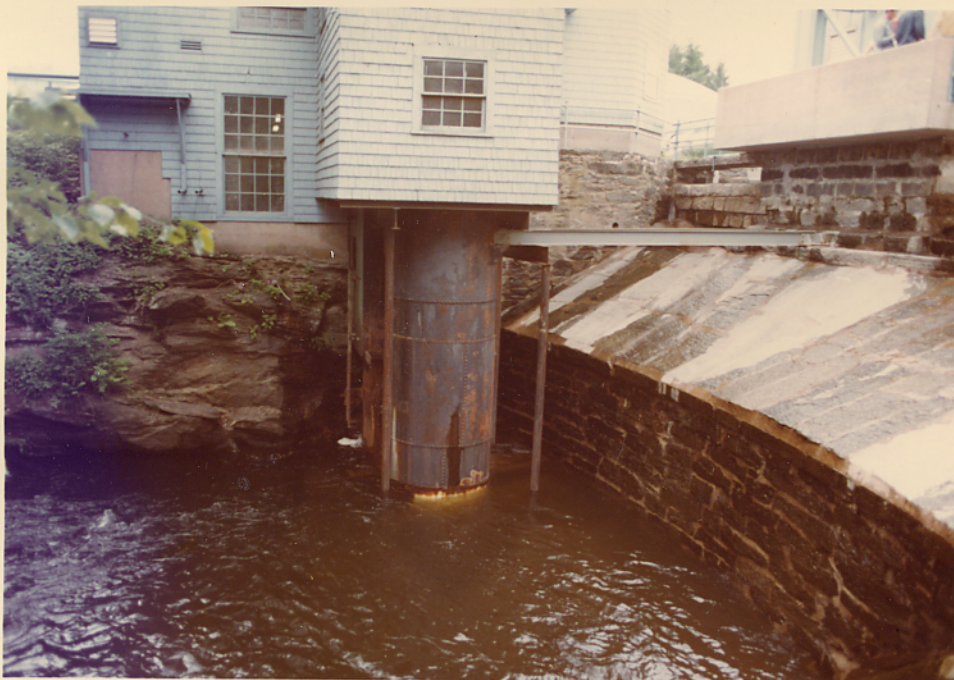
PHOTO 4
SPILLWAY - LOWER GATE HOUSE

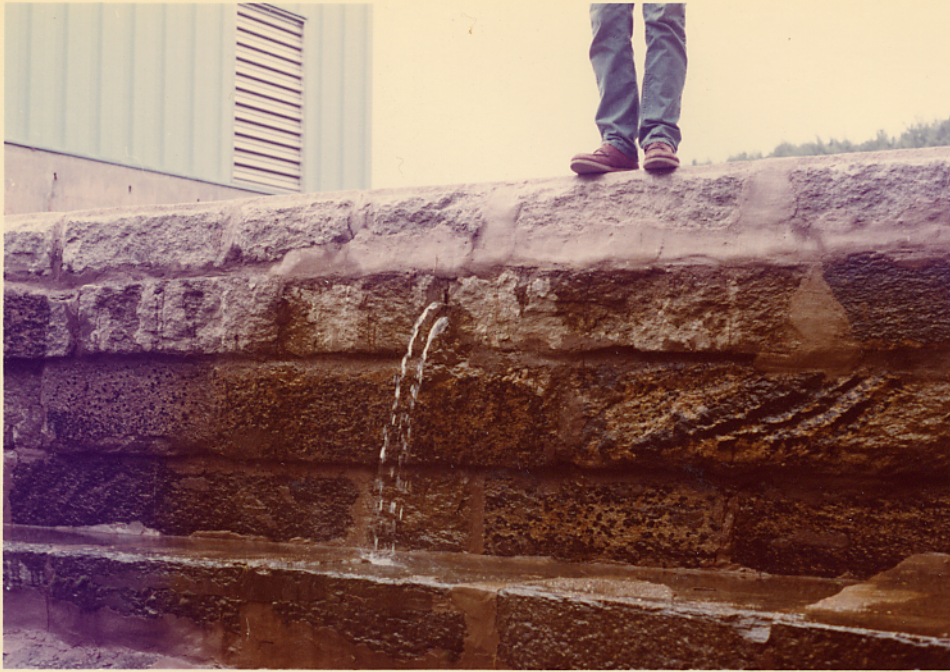
b. Dam - The body of the dam is made up of granite block stone masonry with mortared joints. There were several minor leaks from the joints in the face of the spillway. The condition of the mortar beneath the surface could not be determined. The relationship of the dam to the adjacent rock surfaces showed no evidence of slippage or movement. Measurement of the seepage discharge from the face of the dam was approximately 5 to 6 gallons/min. Photographs taken in October, 1976 which were made available by the owner showed the area in back of the spillway at a lowered water surface elevation. The photographs did not indicate areas of distress.

PHOTO 5
SPILLWAY - LEAK

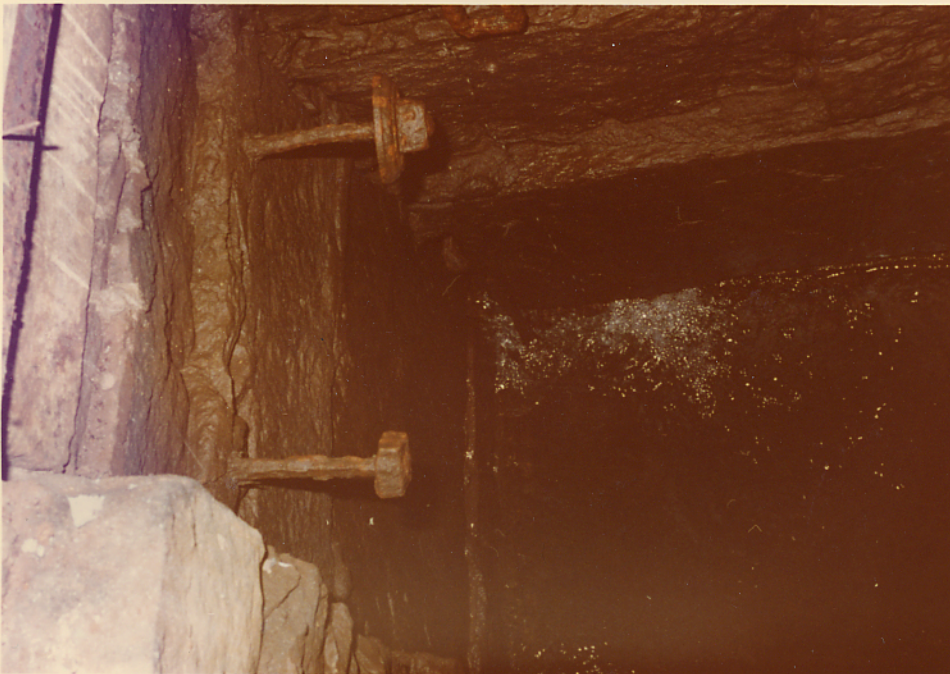
c. Appurtenant Structures - The upper gate house was reconditioned in 1968 in conjunction with the construction of the water treatment plant. Our inspection showed the structure to be in good condition except for water that was leaking into the intake well through the joints in the granite blocks. It appears that the chemical content of the

water in the reservoir causes deterioration of the mortar joints. The replacement of the sluice gates only three years after their installation in 1968 and the condition of the bolts as shown in Photo 6, Appendix C, are further evidence of the deteriorating effect of the water. The penstock pipe was underwater. Maintenance personnel reported no evidence of damage when it was last observed.

PHOTO 6
UPPER GATE HOUSE - WETWELL

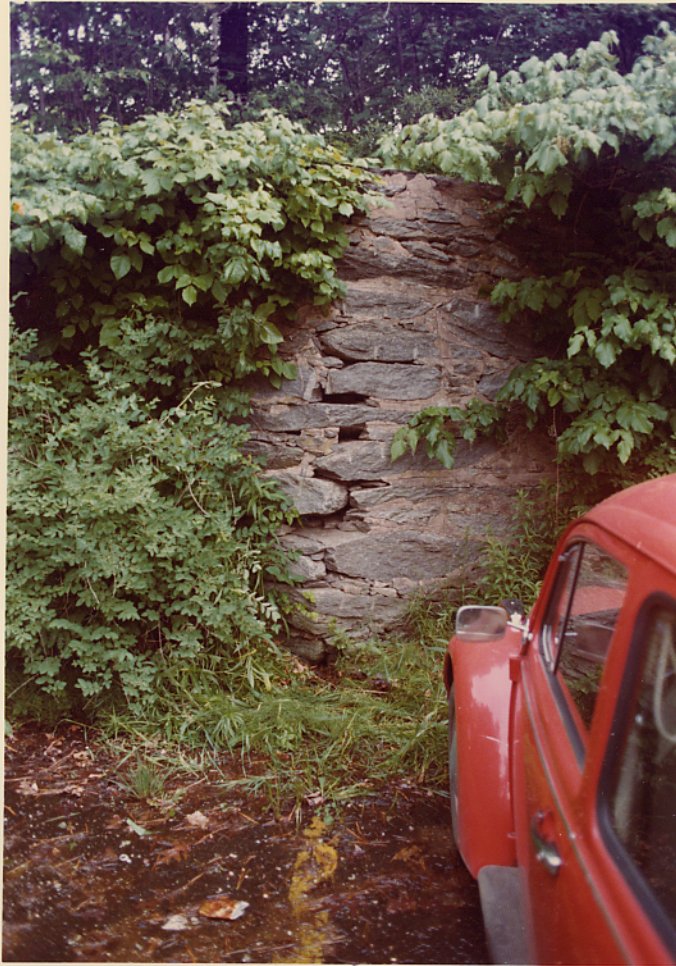
The earth fill dike is faced with granite retaining walls. During the inspection, seepage was observed at the southern corner of the dike which dropped into the parking lot at Roosevelt Mills (Appendix C, Photos 7 and 8). The top of the dike is overgrown with trees and brush. The retaining wall which faces the downstream side of the dike consists of dry rubble masonry.

PHOTO 7
DOWNSTREAM FACE OF DAM - SEEPAGE

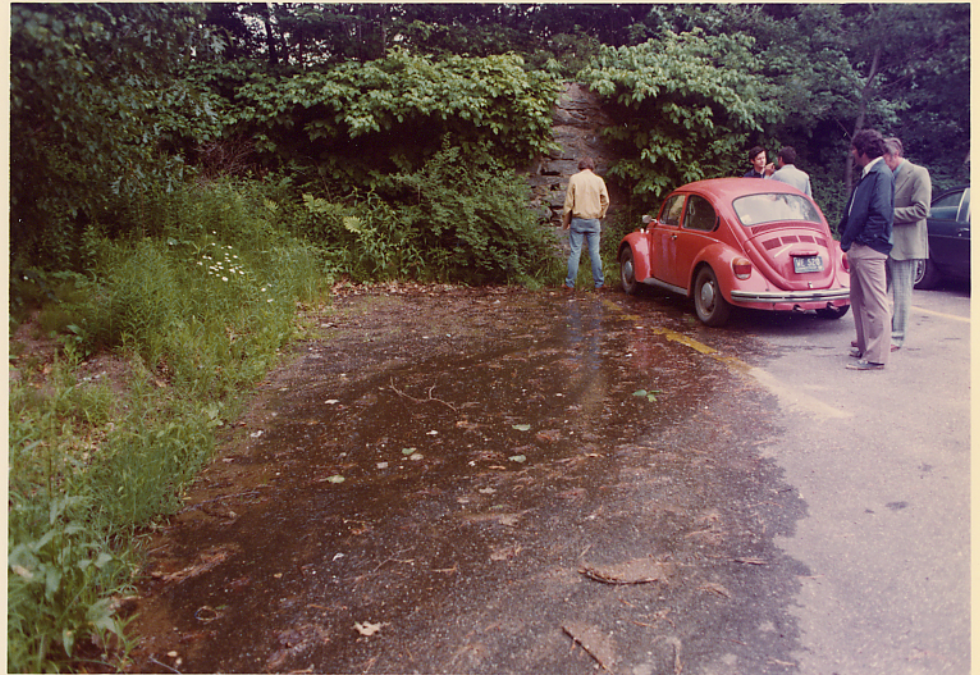
PHOTO 8
DOWNSTREAM FACE OF DAM - SEEPAGE

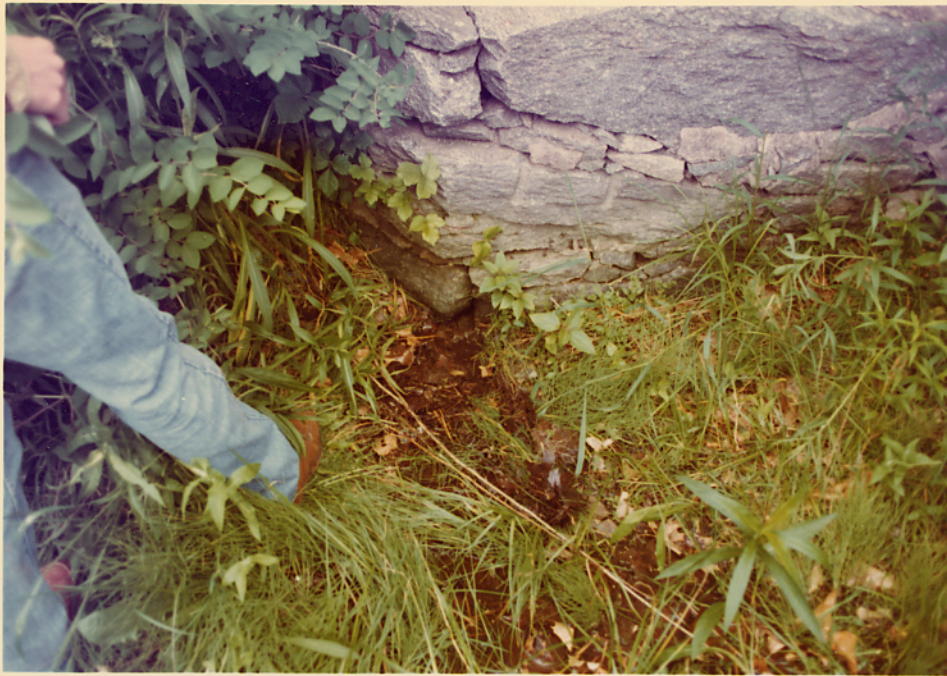
PHOTO 9
DOWNSTREAM FACE OF DAM - SEEPAGE

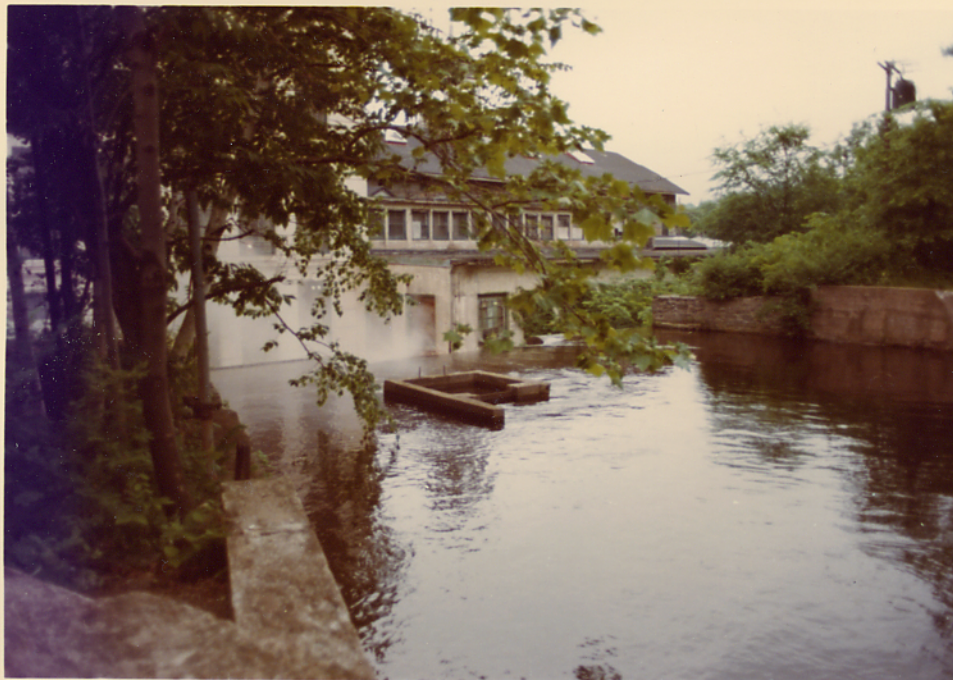
PHOTO 10
DAM 200'± DOWNSTREAM
